Fox Delta

FD- PM3A

PM3A PCB Error & other important points for Kit Builder:

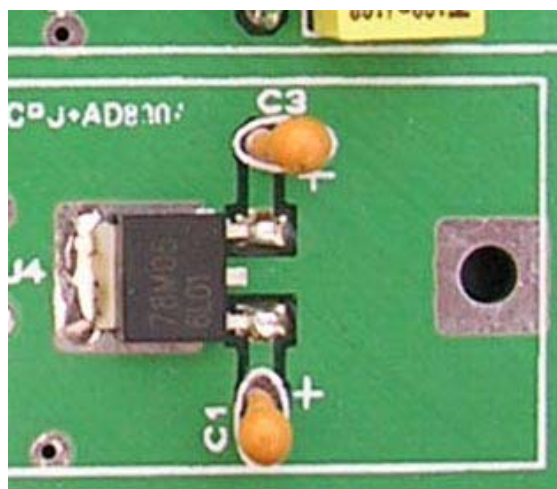
The Wrong is here:

There is a silk print error at C3. Polarity mark is at wrong place.

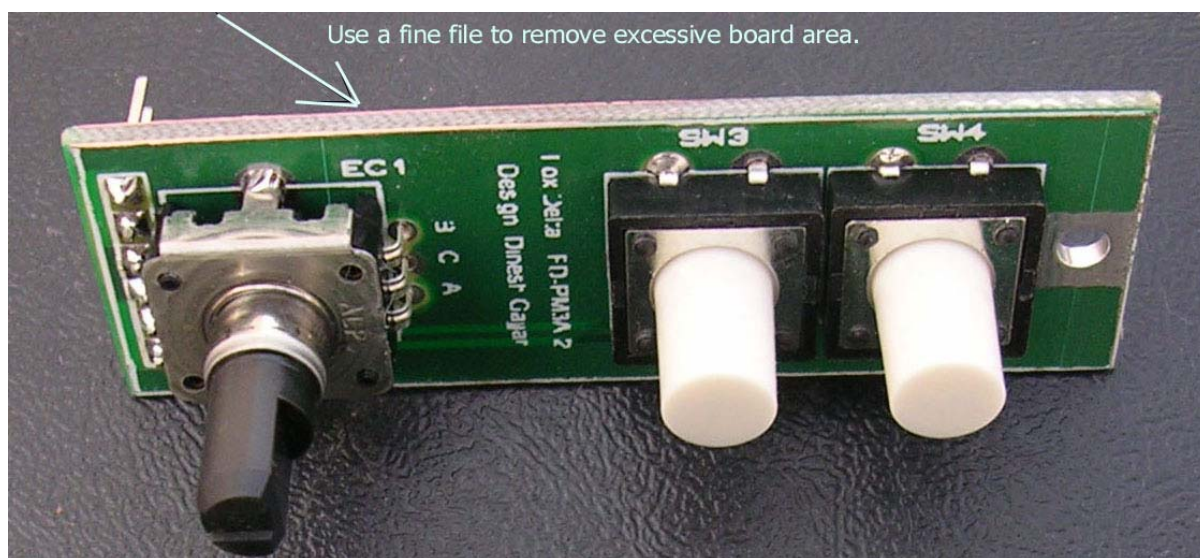
Key Board PCB Width:

Most KB PCBs are ok. Some may be wider by a millimeter. If KB PCB is touching LCD PCB, please grind it using a fine file or sand paper.
